Manhole Inspection Summary

Manhole # S35WW_086MH

Insp Date: **10/30/08 10:11 AM**

Location Address: **3001 BARCLAY ST**

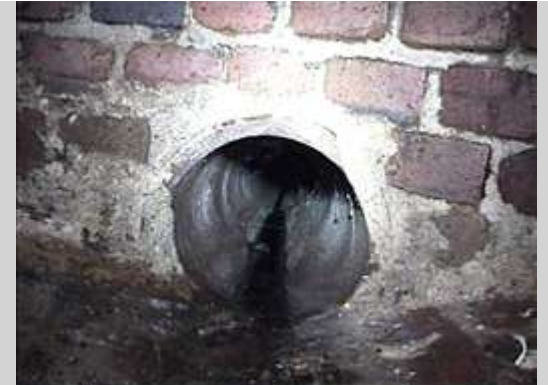
8 in. Circular Gravity Sewer Pipe Out @ 12 O'Clock

Invert Depth: **6.95** (ft.) Flow Characteristics: **Slow**

Deposits: ☒ None ☐ Mud ☐ Sludge ☐ Debris ☐ Grease

Infiltration: **None** Pipe Seal Cond: **Unknown**

Drop: **None**

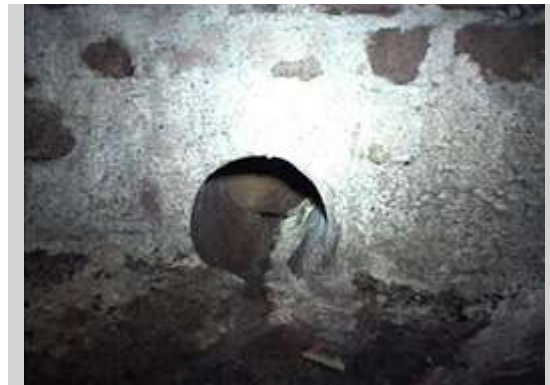
Drop In @ 5 O'Clock

Drop: **Inside** Rod and Bar
Angled: **Yes** Reading: **5.63** (ft.)
Inv Depth: **6.63** (ft.)

Drop Condition: **Open**

Connects To: **House connection / Service line**

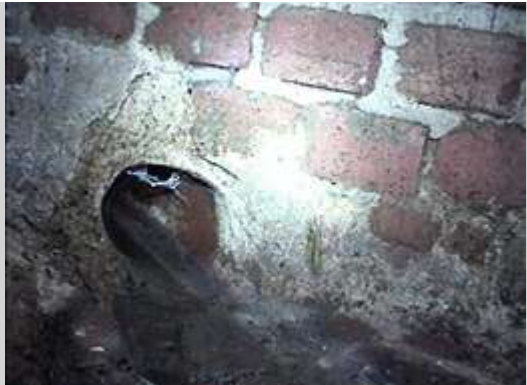
4 in. Circular Gravity Sewer
Pipe In @ 9 O'Clock

Infiltration: **None** Pipe Seal Cond: **Unknown**
